SUBSURFACE INVESTIGATION Neal Road Sanitary Landfill--Module 4 Butte County, California

1P1/397/179 Location: 39121-F6:186N:296W

January 1998

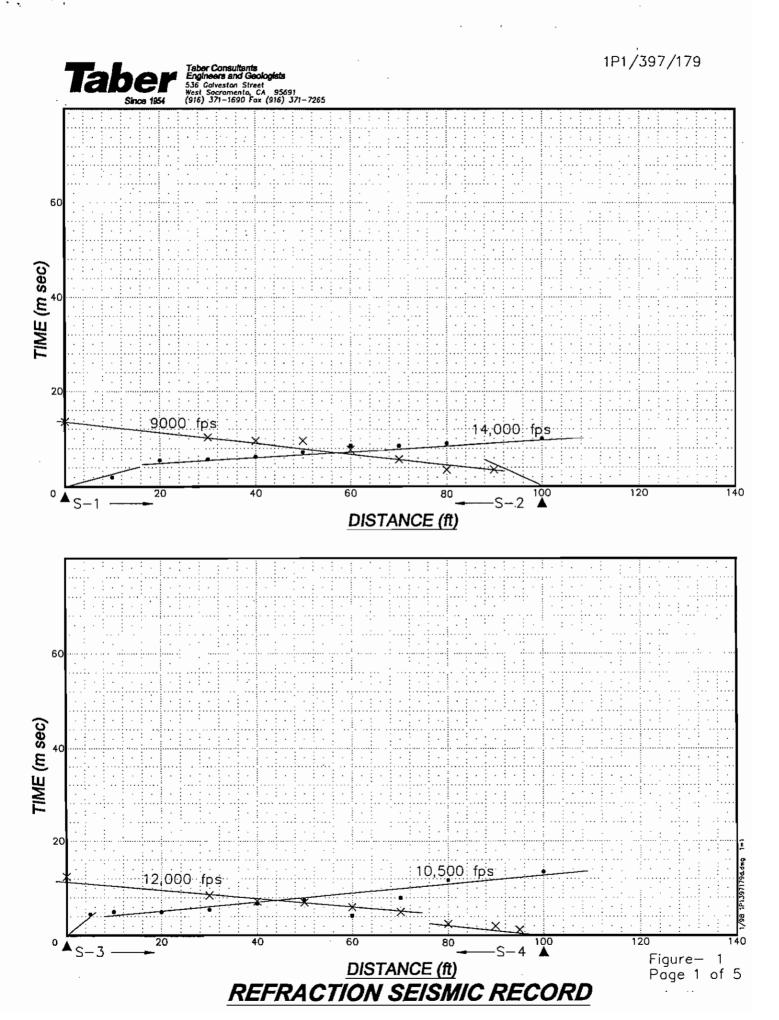
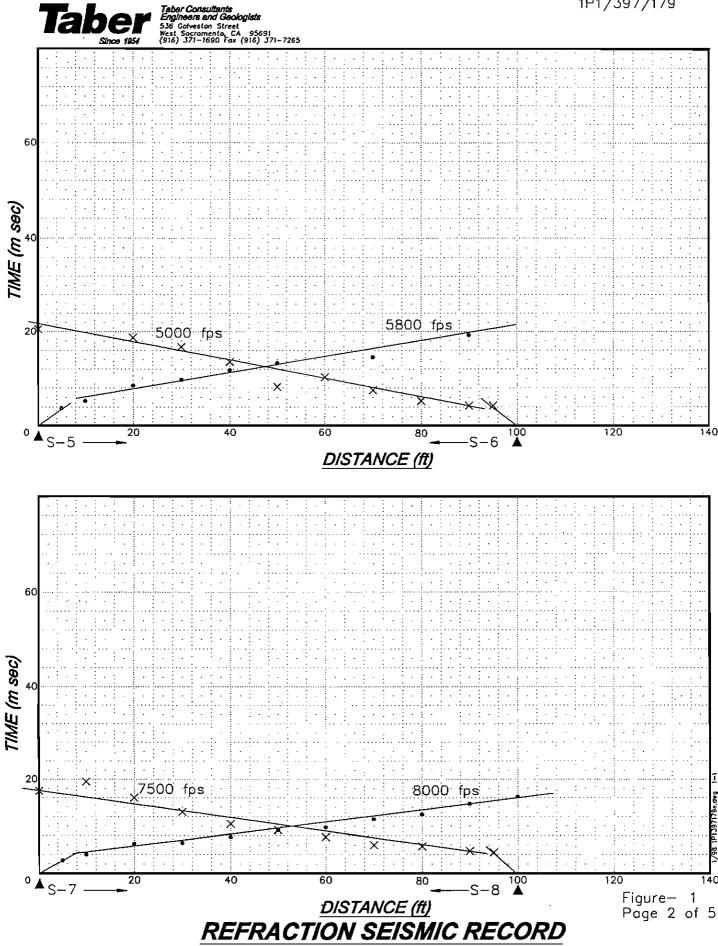
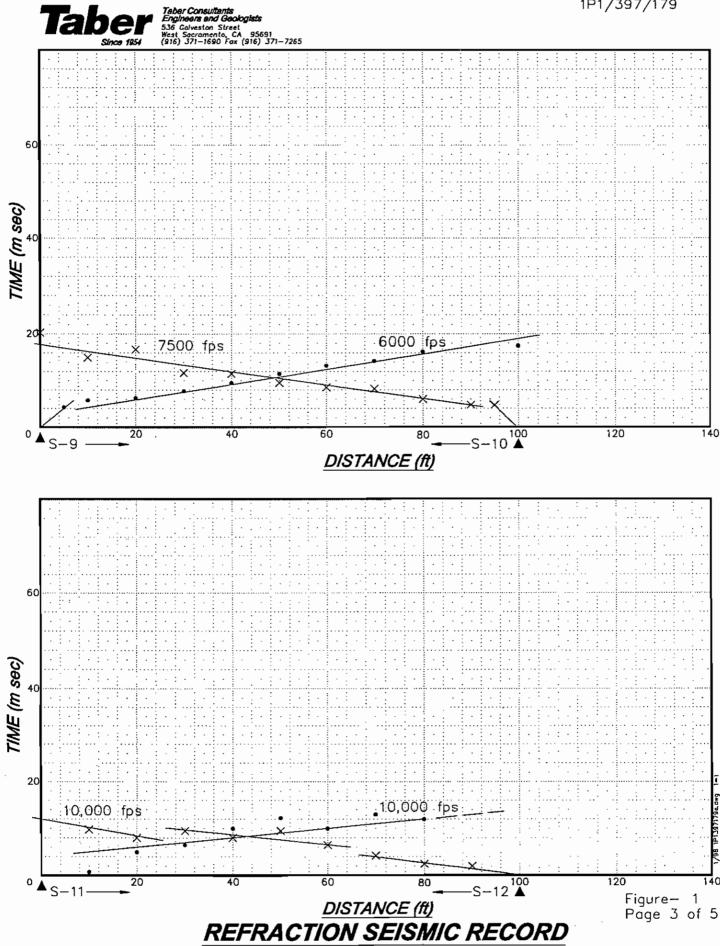
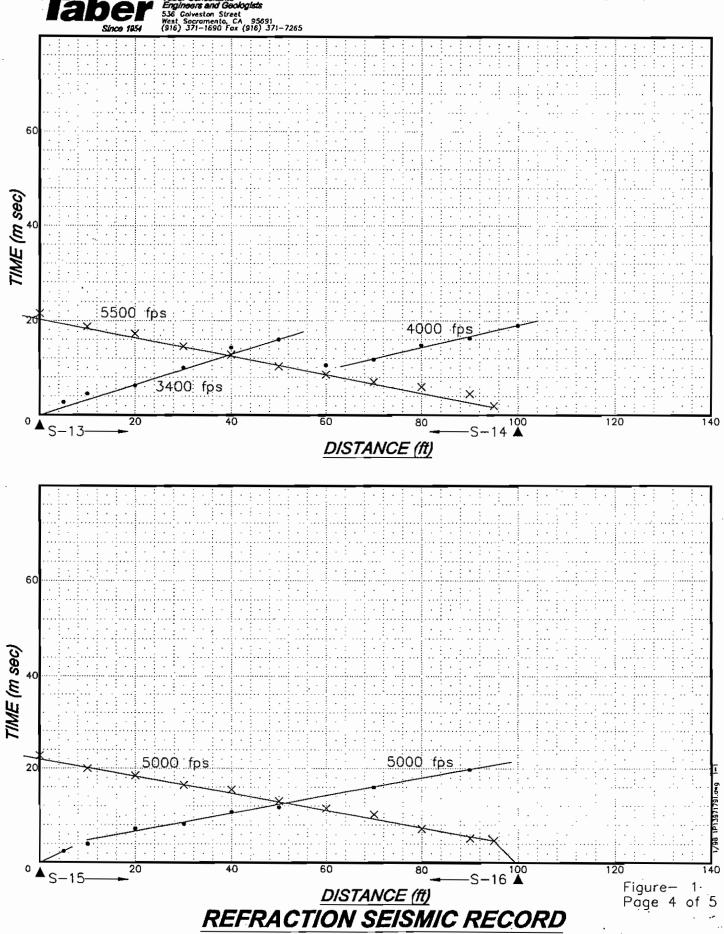
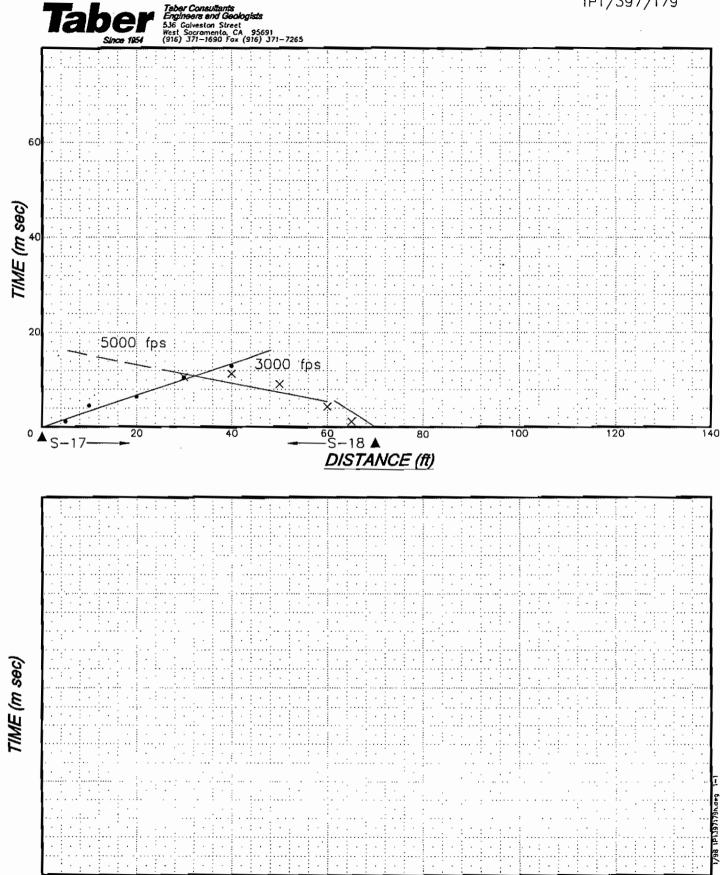
Figure— 1 Page 5 of 5

The refraction seismic profiles are consistent with outcrops and confirm the boring data. Velocities of 9,000-14,000±fps are associated with hard, slightly-moderately weathered lahar. Velocities ranging from 3,400±fps to 8,000±fps (typically on order of 6,000±fps) are considered representative of the weathered sandstone unit underlying the lahar.
